# Summary of pollution events on Rivers Piall and Yealm: week beginning Monday 05 December 2022

Tony Hawkins and Julia Bertram  
30 January 2023

## 1/4 The River Yealm

## 2/4 Timeline of pollution event

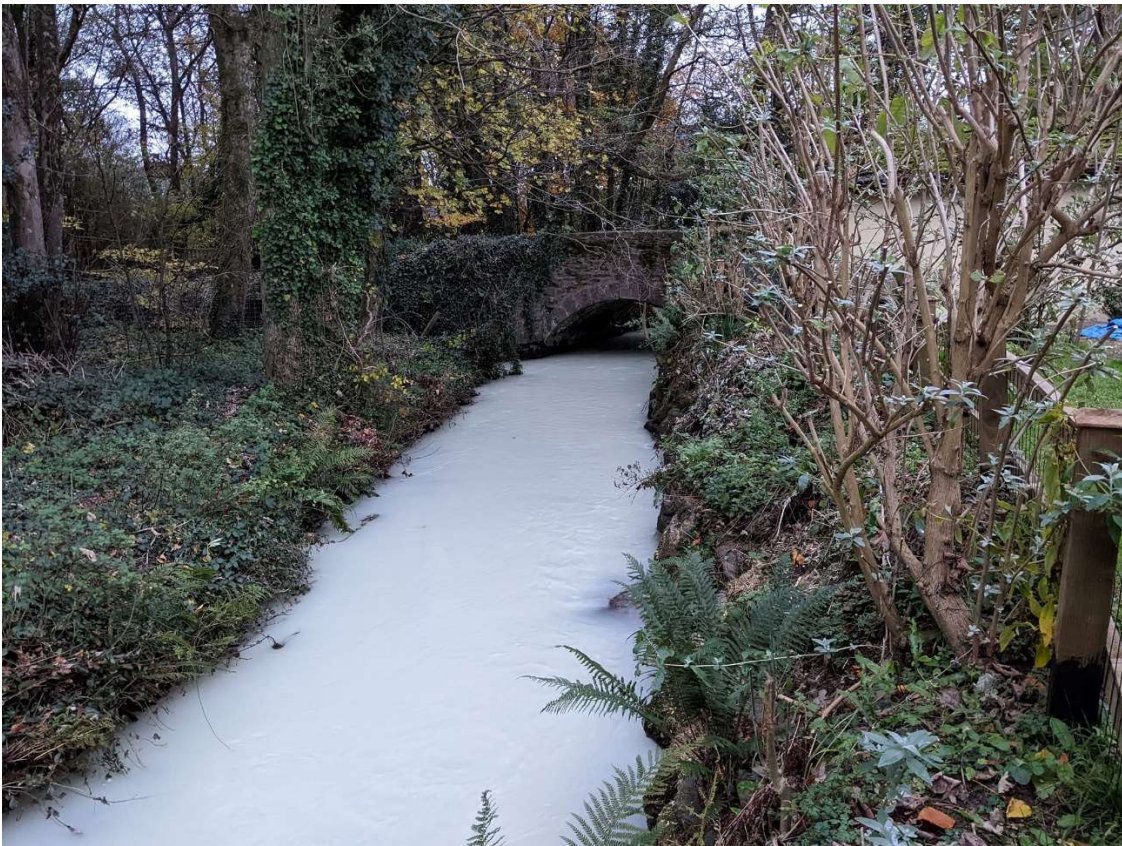
Figure 1: River Piall reported to the EA by Liz Thomas 0830h 05Dec22

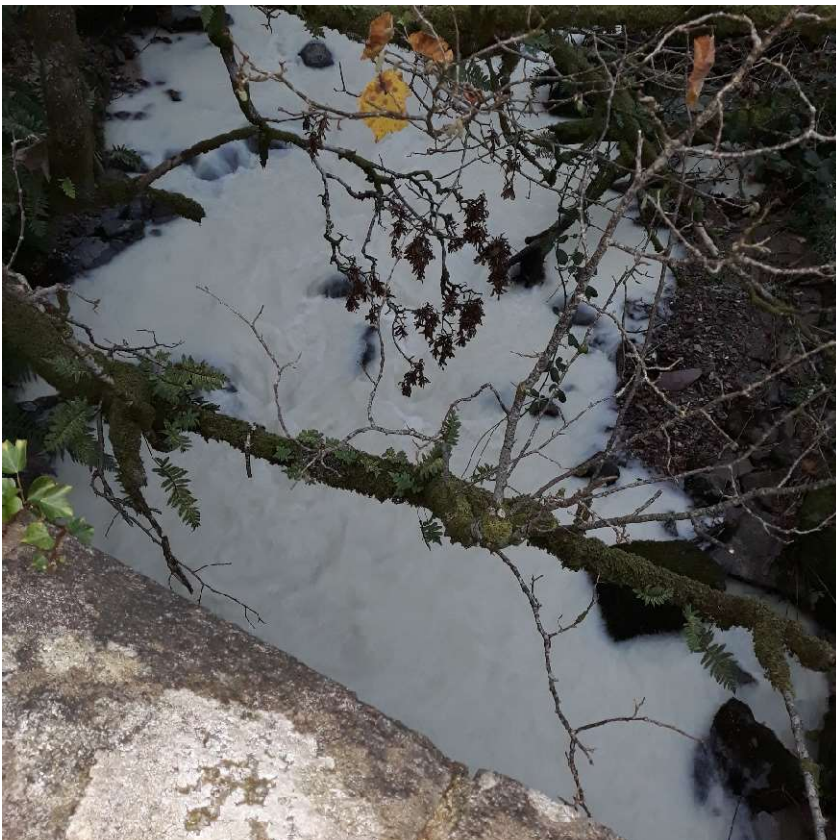
Figure 2: River Piall reported to the EA by Gillian Glegg 0855h 05Dec22

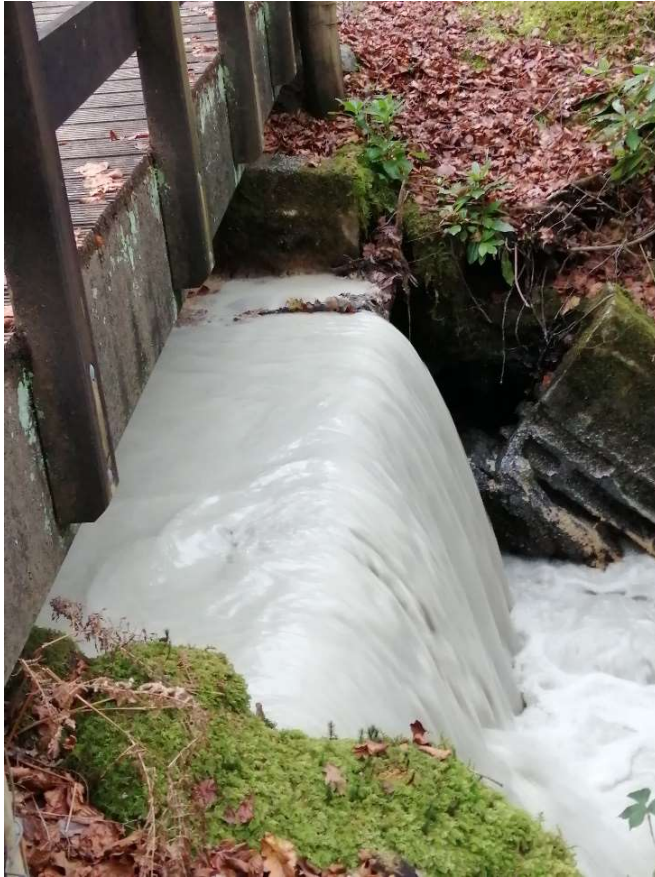
- Photographic evidence taken at 1015h of unusually high water flow saturated with kaolin-like material above Quick Bridge on the River Piall showed the source as having been the tributary from direction of Broomage Waste and Headon China clay works (Figures 3, 11 and 15). At the same time, the associated tributary from Quick Wood to River Piall above Quick Bridge (Figure 15) was running lower and clear. This was witnessed by an EA officer observed on site there at the same time.

Figure 3: Weir on tributary from Headon China clay works to Quick Bridge on River Piall recorded by Julia Bertram 1015h 05Dec22

Notably, about 12 previous consecutive monthly photographs of the weir illustrated in Figure 3 have been uploaded to the WRT Cartographer database. Those photographs collectively establish the exceptionally high flow associated with this pollution, in the absence of significant rainfall; and from which photographs, this additional flow might presumably be estimated.

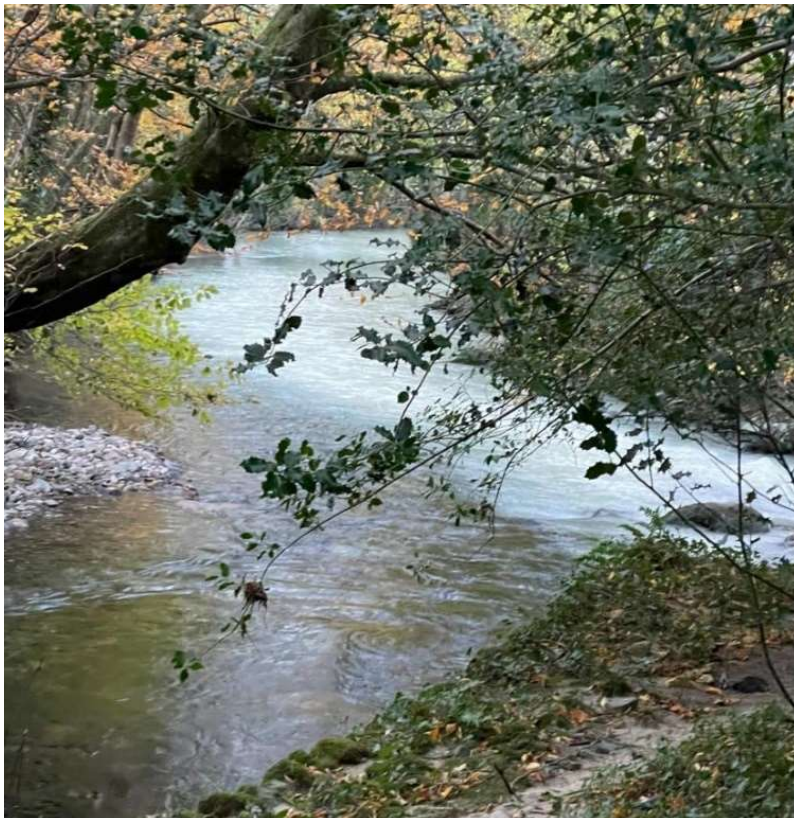
- From its junction with the River Piall, the River Yealm was discoloured through its full length (Figures 1 to 8).
- Pollutant input to the River Piall was observed continuously for at least 6 hours from about 0800 to about 1400h.

Figure 4: Junction of Rivers Piall and Yealm recorded by Kim Thomson 0830h 05Dec22

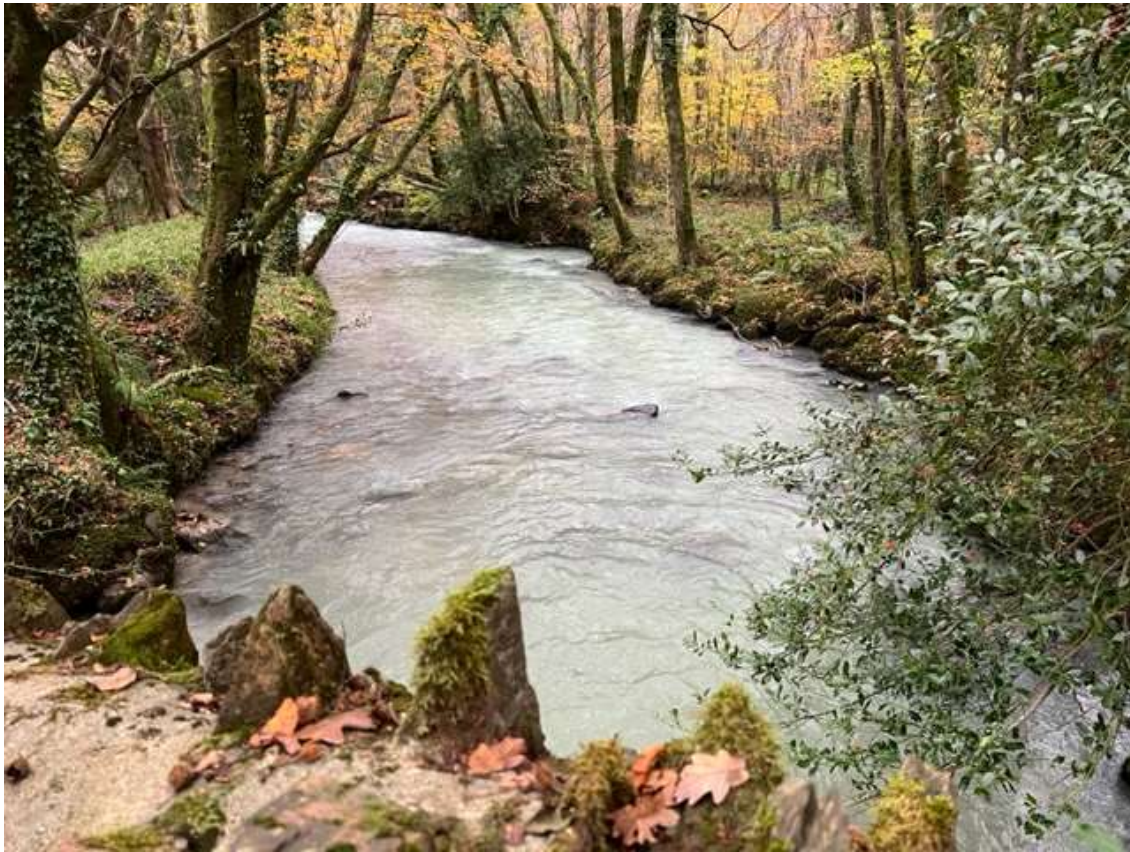
Figure 5. River Yealm at Popple's Bridge, about 5 miles downstream of Quick Bridge, recorded by Neil Tugwell 0950h 05Dec22

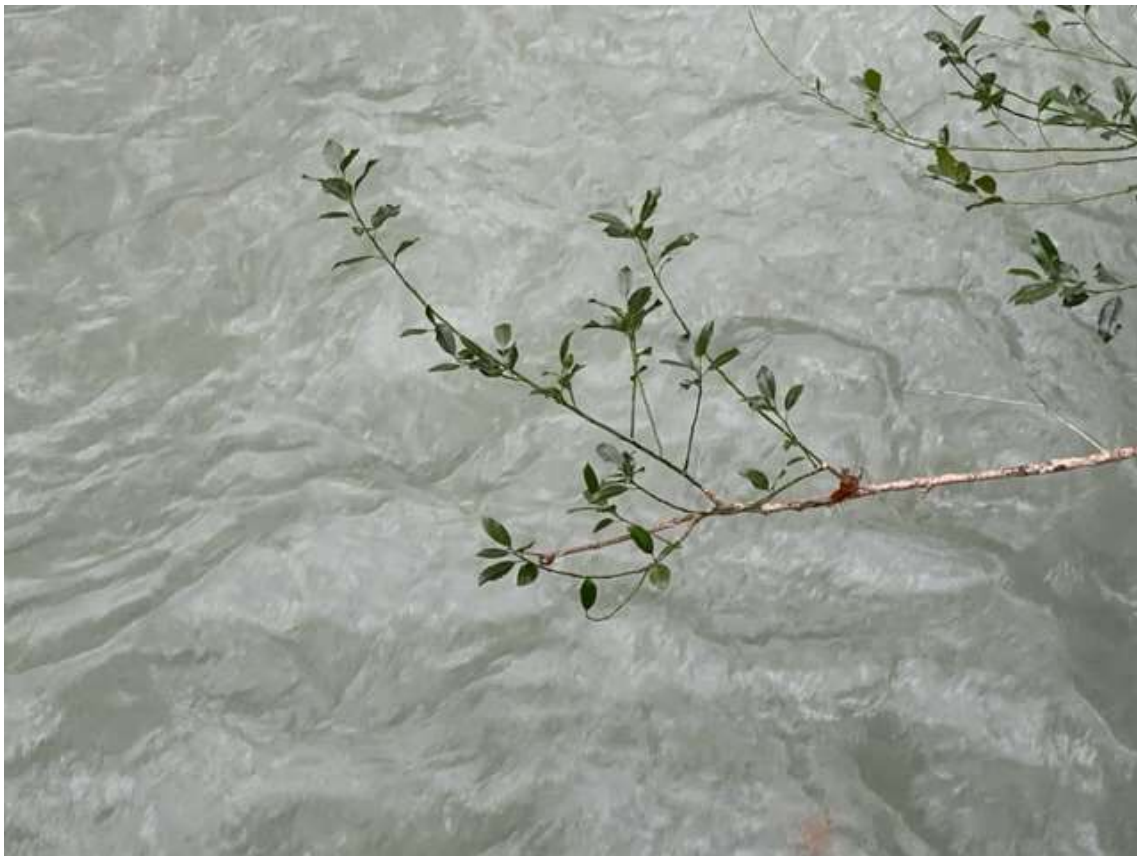
Figure 6. River Yealm at Popple's Bridge, about 5 miles downstream of Quick Bridge, recorded by Neil Tugwell 0950h 05Dec22

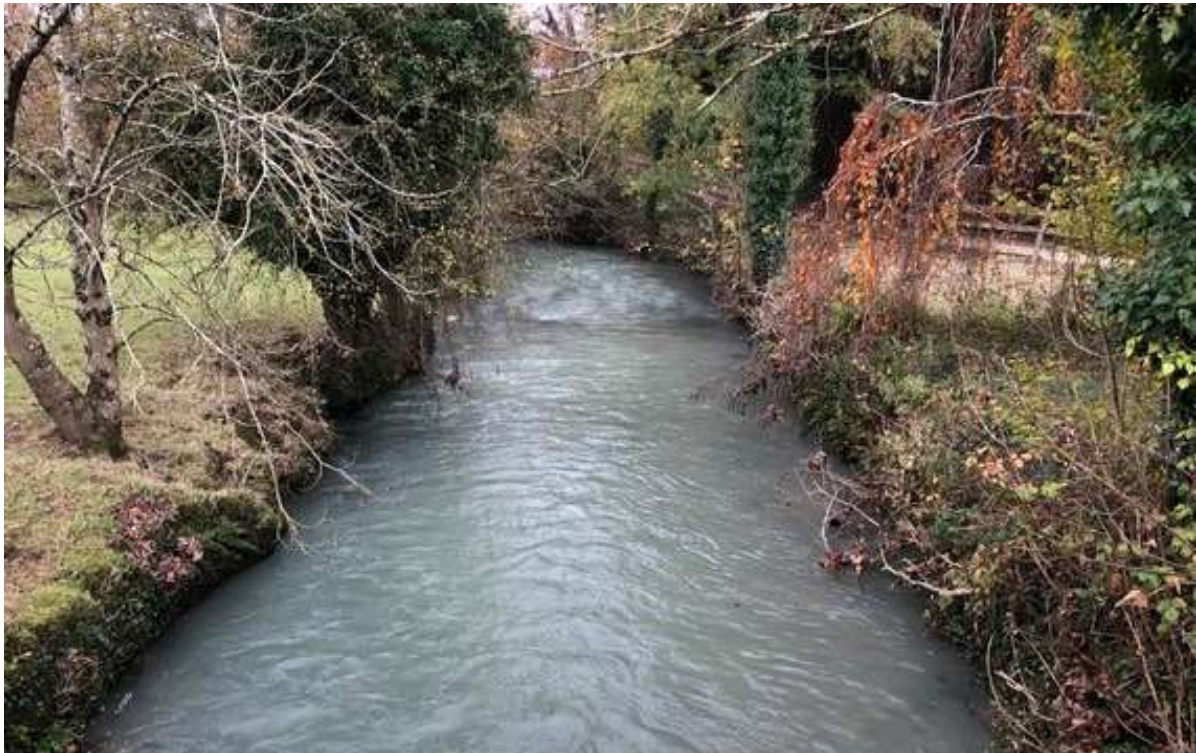
Figure 7: River Yealm at Worston Mill, about 6 miles downstream of Quick Bridge, recorded by Charles Weston-Baker 1354h 05Dec22

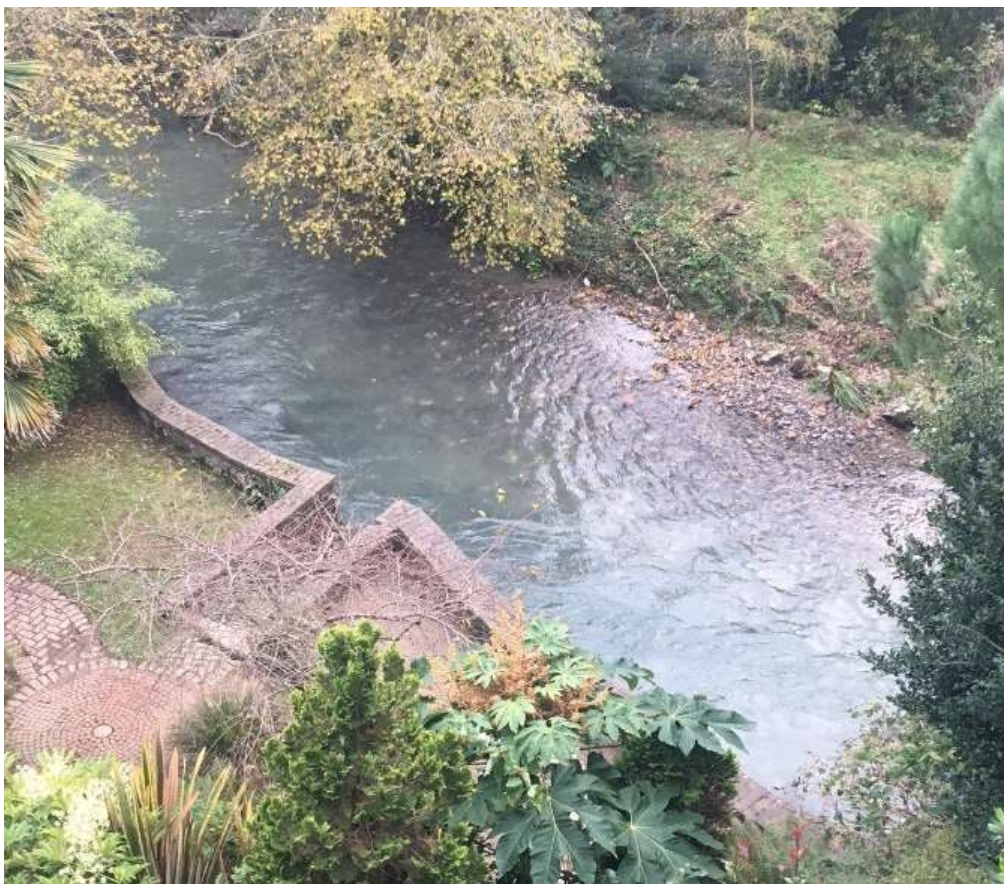
Figure 8: River Yealm below Yealm Bridge, about 8 miles downstream of Quick Bridge, recorded by Tony Hawkins 1444h 05Dec22

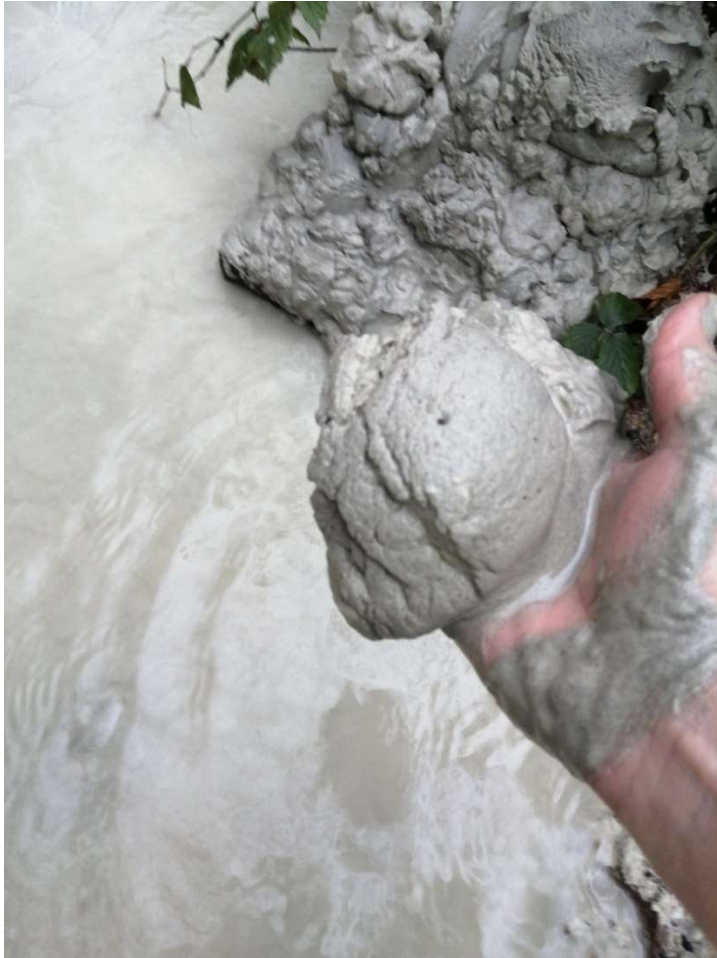
- Associated deposits on bed of River Piall were measured of more than 15 cm depth (Figures 9, 10 and 11).

Figure 9: Kaolin-like deposits at Piall Bridge, about 0.5 miles downstream of Quick Bridge, reported to the EA by Julia Bertram late morning 1430h 05Dec22

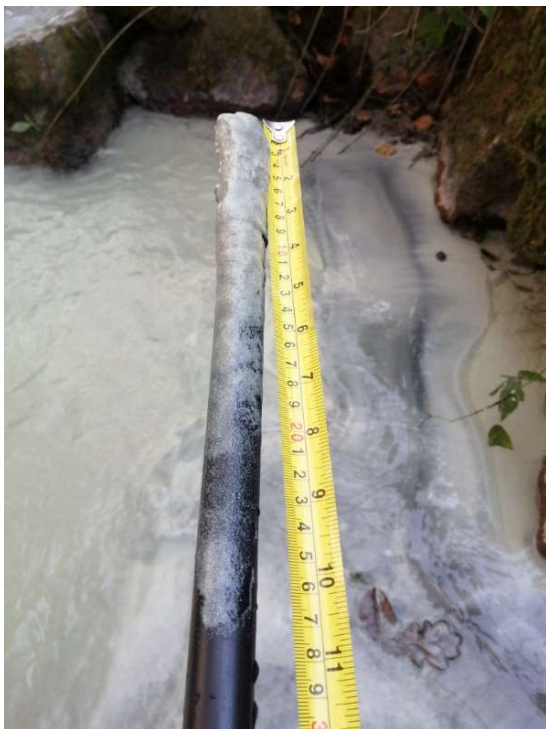
Figure 10: Kaolin-like like deposits measured as more than 15 cm deep at Piall Bridge, about 0.5 miles downstream of Quick Bridge, recorded by Julia Bertram 1430h 05Dec22

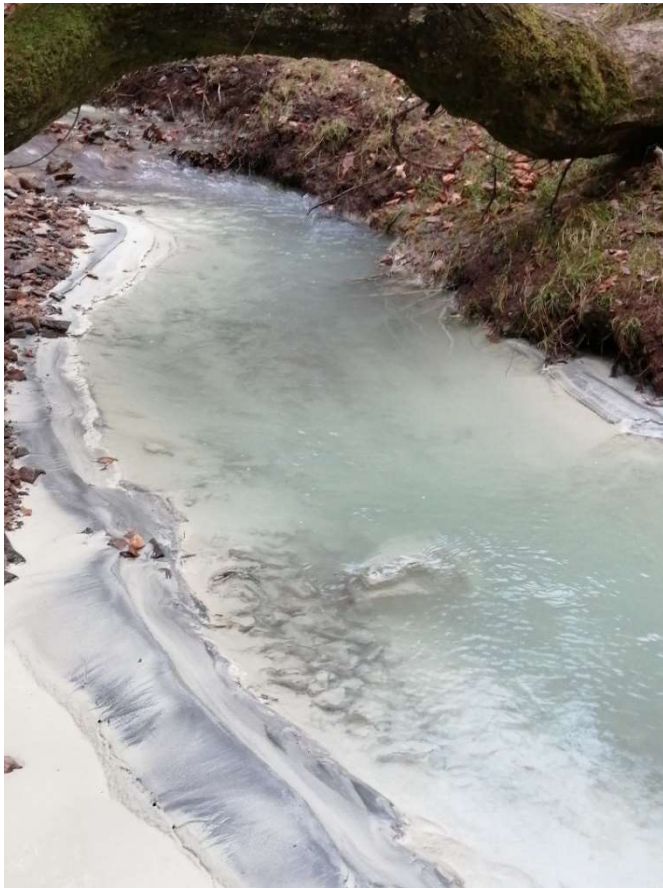
- Heavy deposits on banks and bed of left-hand tributary looking upstream from Quicks Bridge on the River Piall, towards Headon China clay works, confirmed this as the source of pollution (Figures 11 and 15).

Figure 11: Heavy deposits on banks and bed of left-hand tributary looking upstream from Quicks Bridge on the River Piall, towards Headon China clay works, recorded by Julia Bertram 1415h 05Dec22

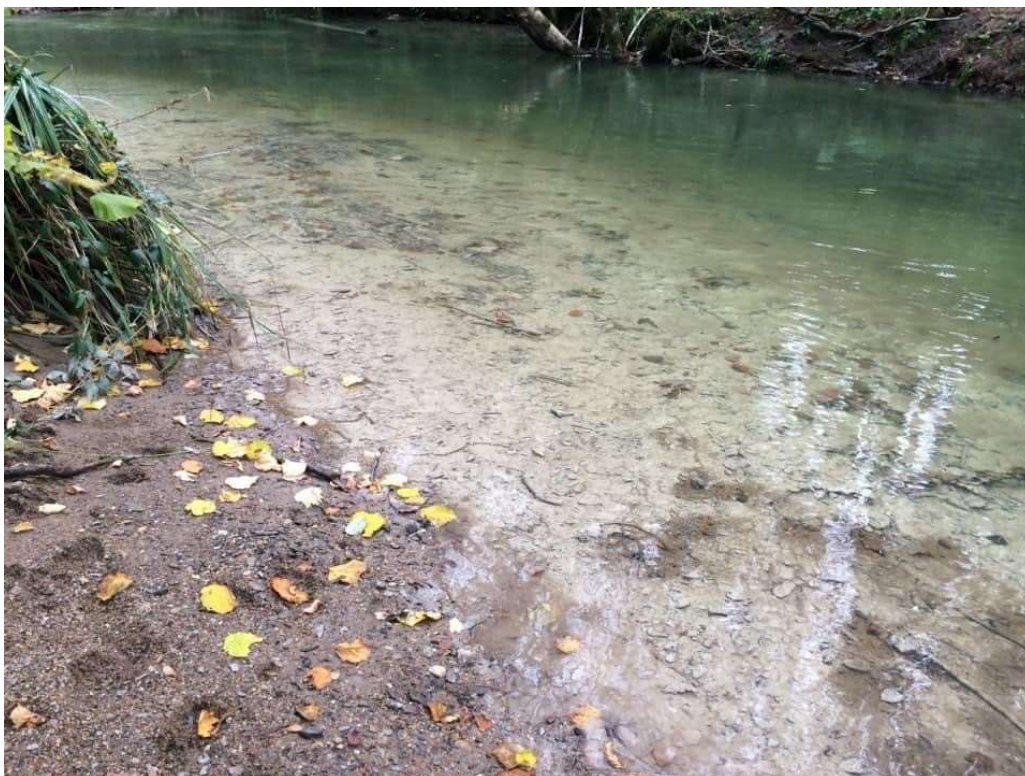
- Heavy deposits were recorded as far as 5 miles downstream (Figure 12).
- We have a report of dead fish, which information and contact details have been shared with the EA.

Figure 12 : Heavy deposits on bed of River Yealm close to Lotherton Bridge, about 5 miles below Quick Bridge, recorded by Chris Westwood 07Dec22

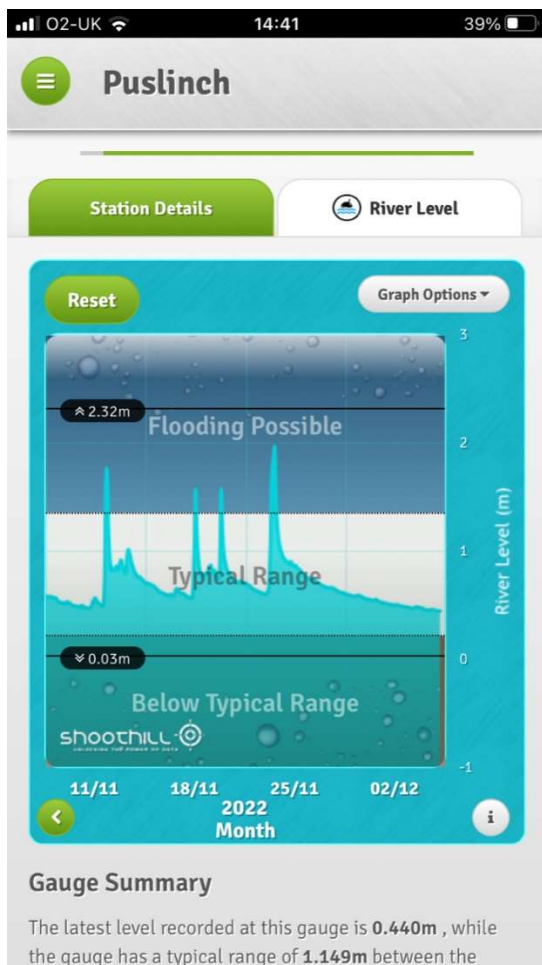
There had been no significant rain for the previous 7 days, and when water levels were towards the bottom of typical range (Figure 14). Therefore, there can have been no immediate need for discharge. Further to which, it is clear that the scale of pollution far exceeded licensed conditions for such discharge, in any case flowing in large part outside of “normal” (licenced) watercourses (Figures 17, 18, 22, 23 and 24).

Figure 14: Height of River Yealm recorded at Puslinch Gauging Station, establishing no significant rainfall in the seven days prior to event of 05 December 2022

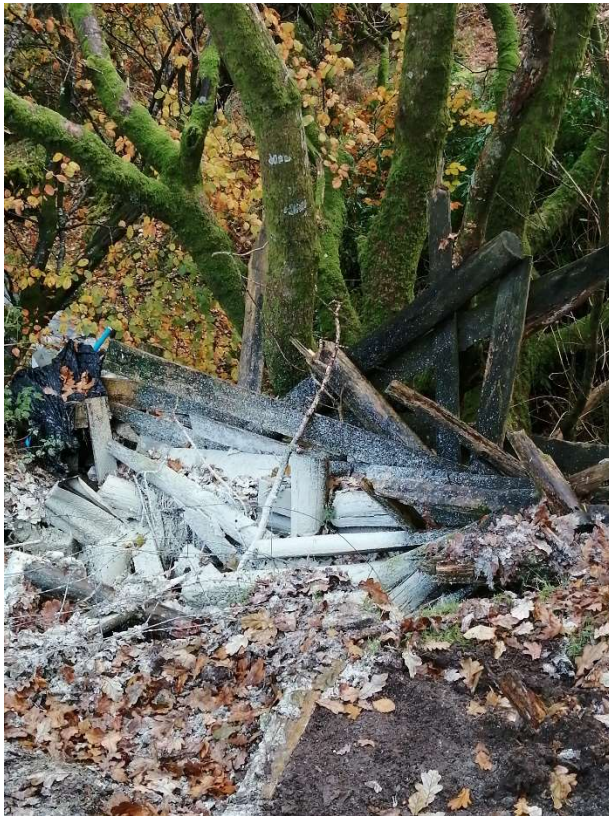
- There has been no significant rain since Monday 05 December, such that photographs taken on Saturday 10 December illustrate the height of polluted water that must have swept down (i) PROW footpath 25, as evidenced by deposits at least 2 feet above that path on bordering trees and fencing (Figures 17 and 18); including (ii) the top end of tributary from Broomage down to Quick Bridge, as evidenced by deposits on bordering reeds about 1 foot above the current water level (Figure 19).

Figure 17: Deposits on the remainder of fencing bordering PROW Footpath 25 recorded by Julia Bertram 1120h 10Dec22

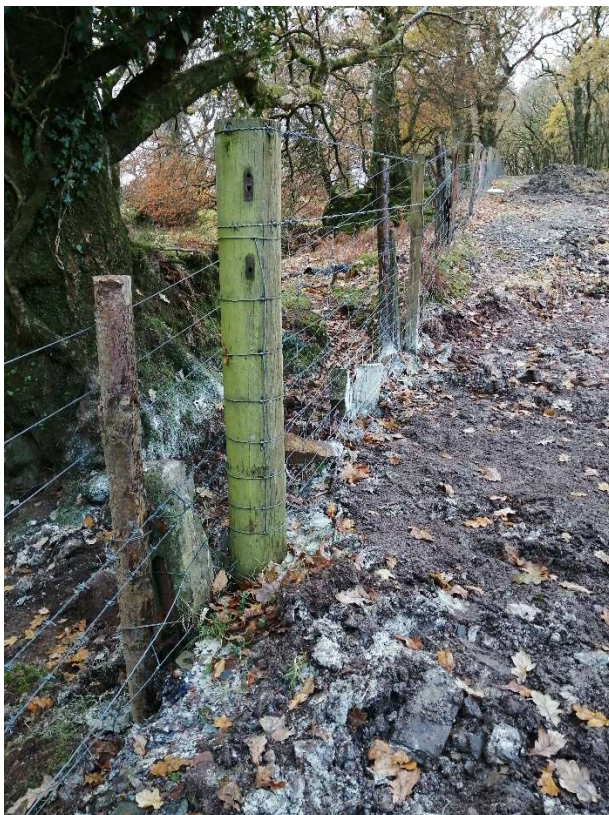
Figure 18: Deposits on tree trunk bordering PROW Footpath 25 recorded by Julia Bertram 1120h 10Dec22

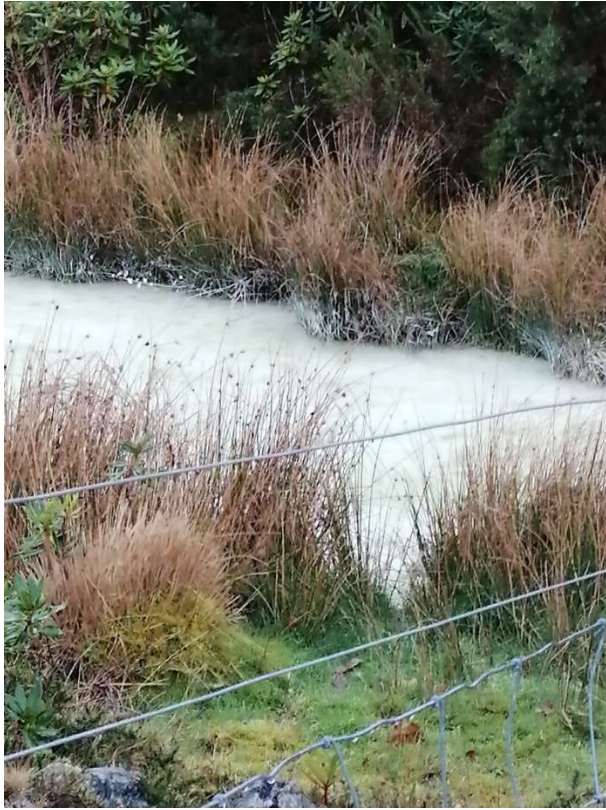
Figure 19: Deposits on reeds bordering the top end of tributary from Broomage down to Quick Bridge (in this photograph, the water is actually running clear above a thick layer of white sediment, which apparently is “normal” at this location)

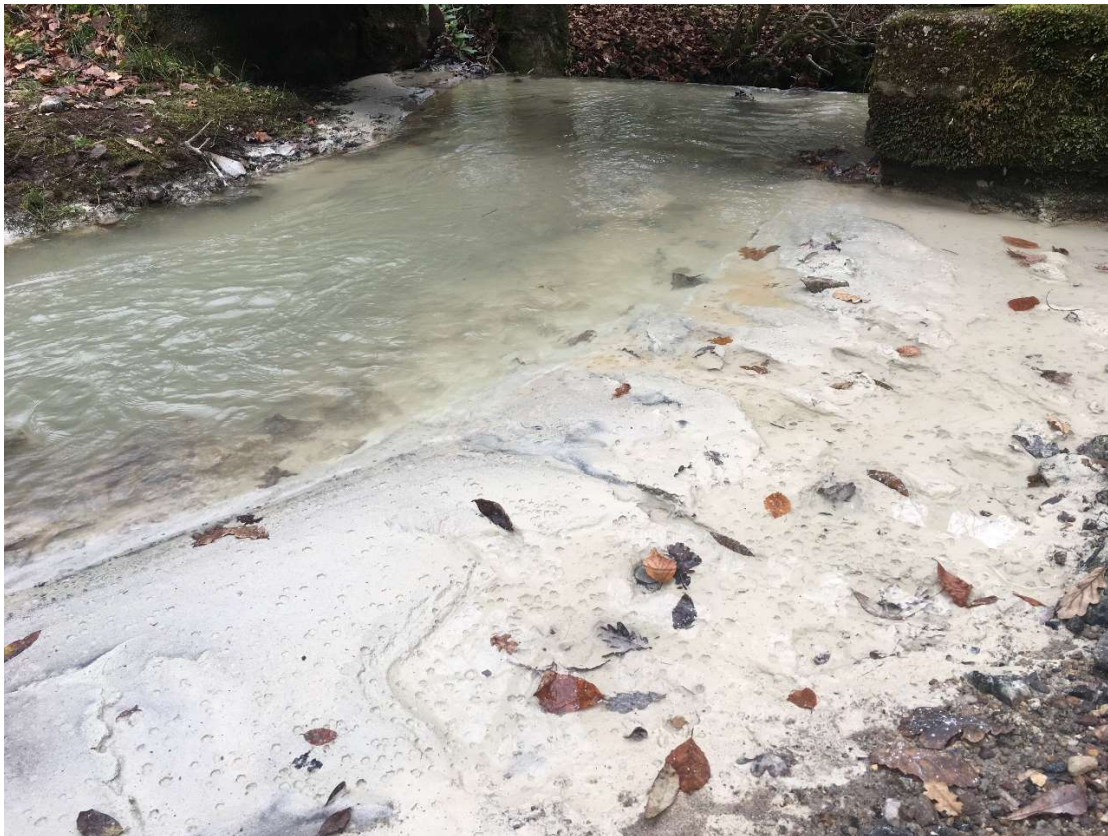
- Eight days on following the pollution event of Monday 05 December, thick deposits of kaolin-like material remain on the banks and beds of River Piall (Figures 20 and 21).

Figure 20: Deposits remaining above the weir on tributary from Headon China clay works to Quick Bridge on the River Piall recorded by Tony Hawkins 1005h 14Dec22

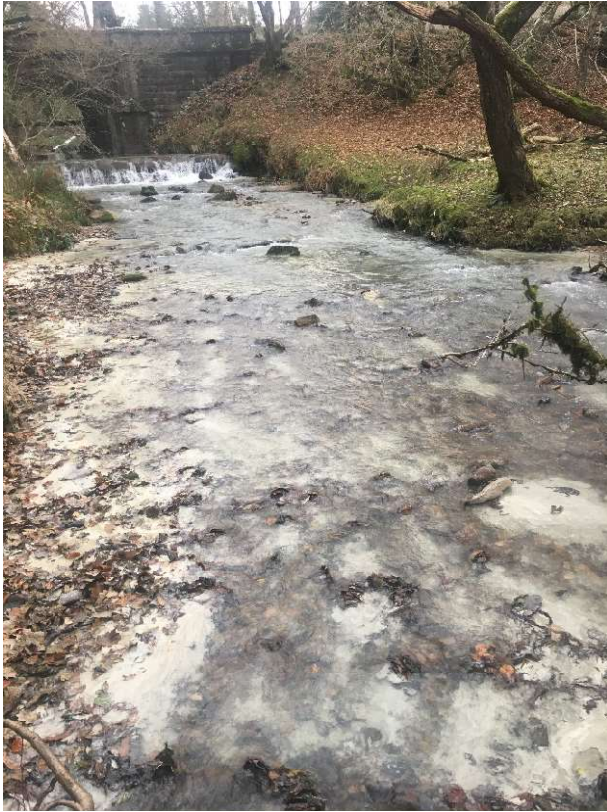
Figure 21: Deposits remaining below Piall Bridge recorded by Tony Hawkins 0950h 14Dec22

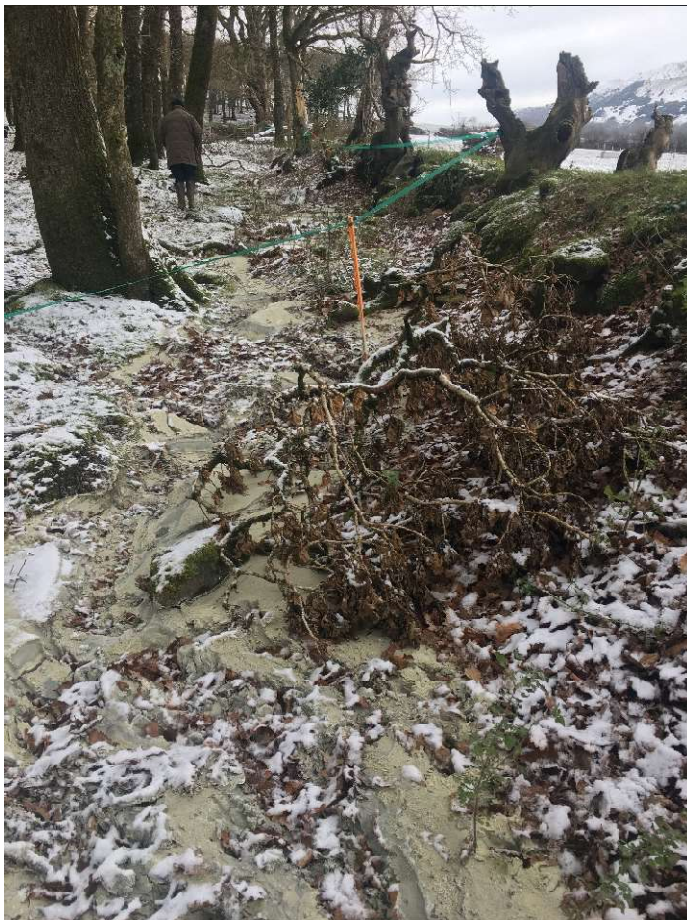
- The source of pollution onto PROW footpath 25 was traced up through Broomage Wood (Figure 22) into field above Tin Park (Figure 23). The area there has been cleared very recently using tracked vehicles, presumably on Mon 05 December as suggested above, and a significant dry-stone wall of about 10 metres length also rebuilt close to the area where pollution appears to have issued (Figures 23 and 24).

Figure 22: Recent deposits of kaolin-like matter running down the side of Broomage Wood to PROW Footpath 25 recorded by Tony Hawkins 1010h 14Dec22

- Deposits from overland pollution running down the side of Broomage Wood to PROW Footpath 25, as evidenced in Figure 22, have been thoroughly cleared away (Figure 26).

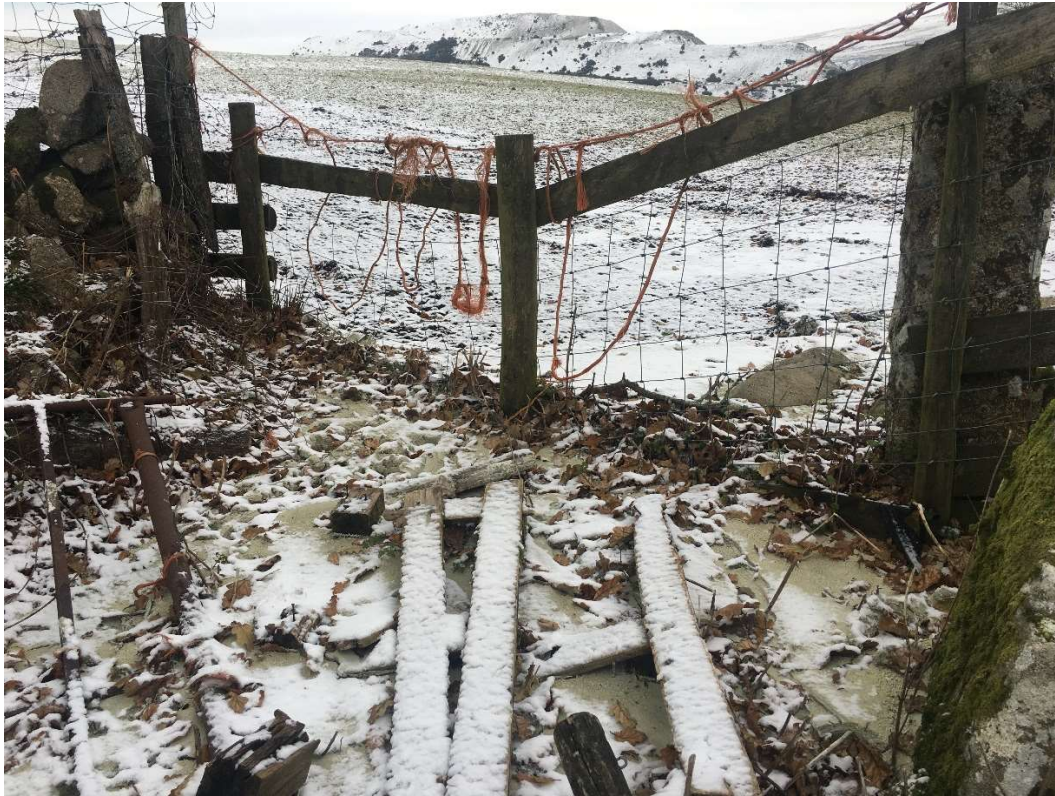
Figure 23: Recent deposits of kaolin-like material evidencing overland pollution running into the top of Broomage Wood from field above Tin Park recorded by Tony Hawkins 1020h 14Dec22

In possible explanation, given the evidence and information gathered as described above on Wednesday 14 December, pollution of kaolin-like material into Rivers Piall and Yealm on Monday 05 December may have originated from a pipe above Tin Park. We have yet to establish the exact purpose or location of that pipe. Nor are we aware of any associated statement describing or explaining any such event.

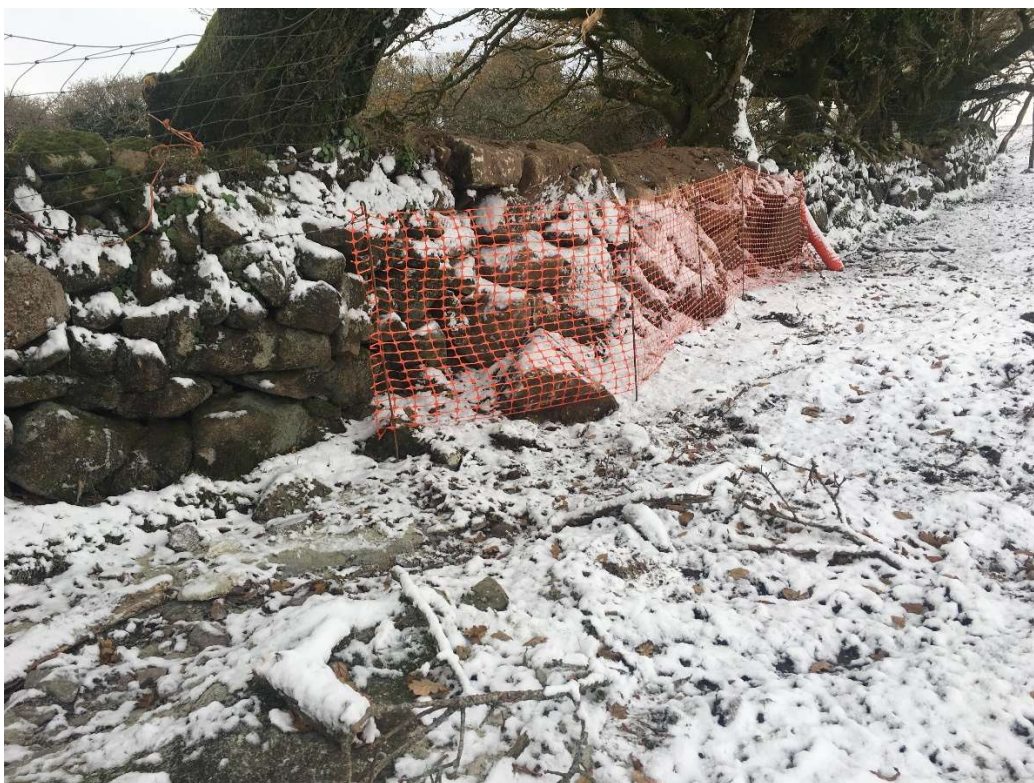
Figure 24: Recent deposits of kaolin-like material evidencing overland pollution running down the side of field above Tin Park from site where hedge has since been rebuilt recorded by Tony Hawkins 1030h 14Dec22

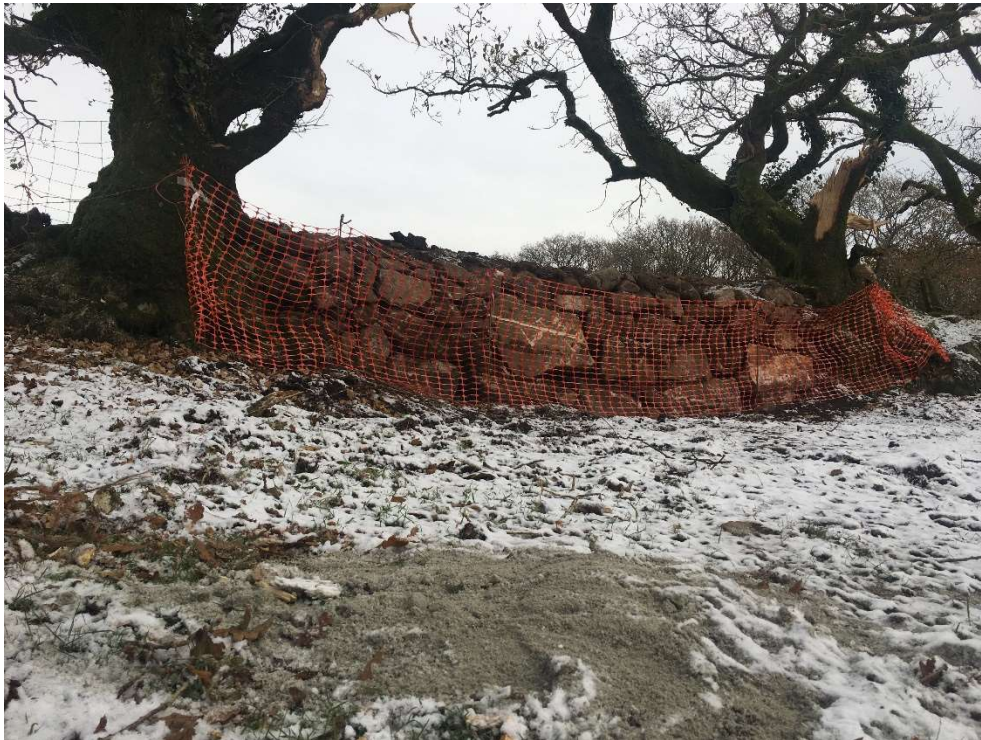
Figure 25: Workings but with no associated evidence of pollution on the western side of rebuilt wall adjoining field above Tin Park recorded by Tony Hawkins 1010h 14Dec22

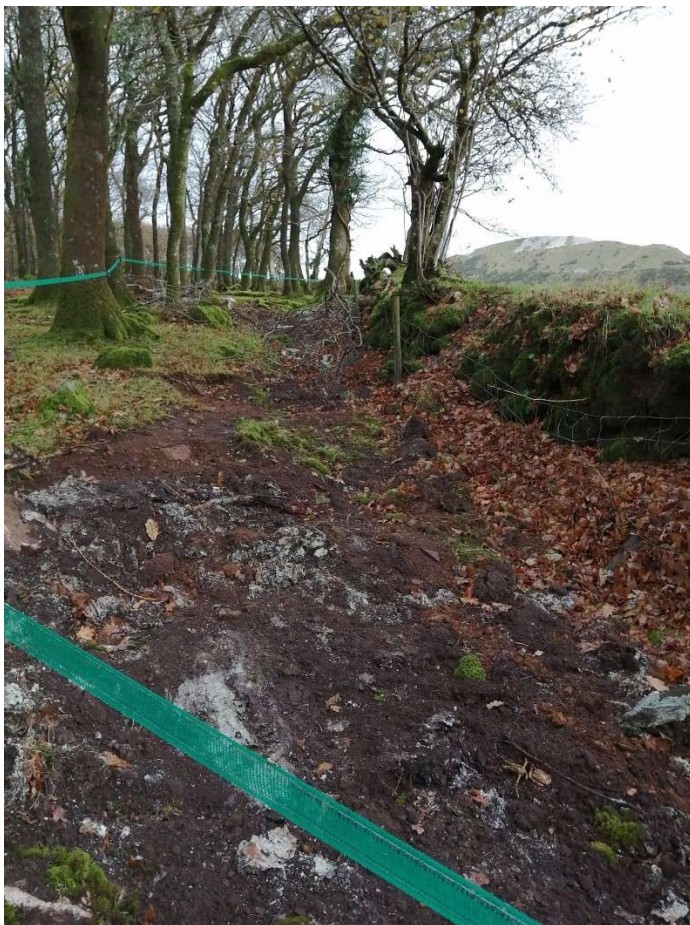
Figure 26: Deposits from overland pollution running down the side of Broomage Wood to PROW Footpath 25 (evidenced in Figure 22) have been cleared away recorded by Julia Bertram 17Dec22

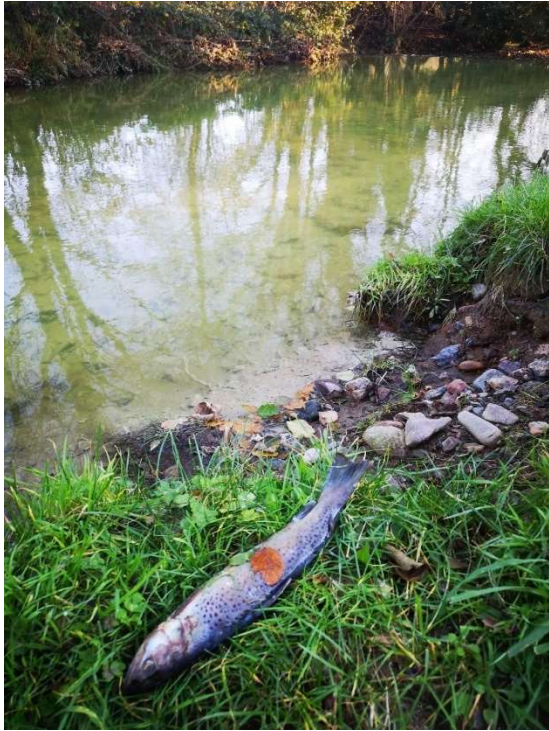
- Further evidence of dead fish was received, this time photographic, of a sizeable sea trout near the weir at Lucas Wood on River Yealm (Figures 27 and 28). These photographs were taken on 06 December, one day after the main pollution event. At the same time, Figure 27

also evidences heavy sediment smothering the river bed. The person who has provided these photographs describes how he gave two staff from the Environment Agency permission to access the river over private property, and who stated they had observed dead fish.

Figure 27: River Yealm by weir near Lucas Wood showing bottom sediment and dead fish recorded by Joe Brewer 06Dec22

Such effects seem likely to have been confirmed by both verbal and pictorial evidence of dead fish (Figure 27 and 28) on our river banks in the days immediately following this pollution event.

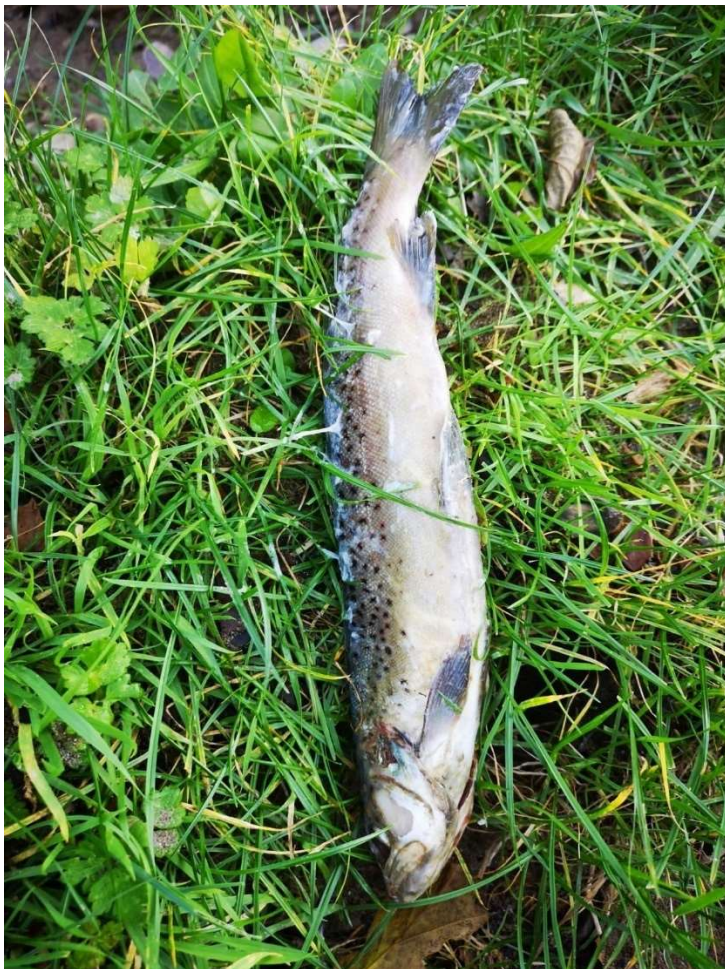
Figure 28: Dead sea trout by weir near Lucas Wood on River Yealm recorded by Joe Brewer 06Dec22

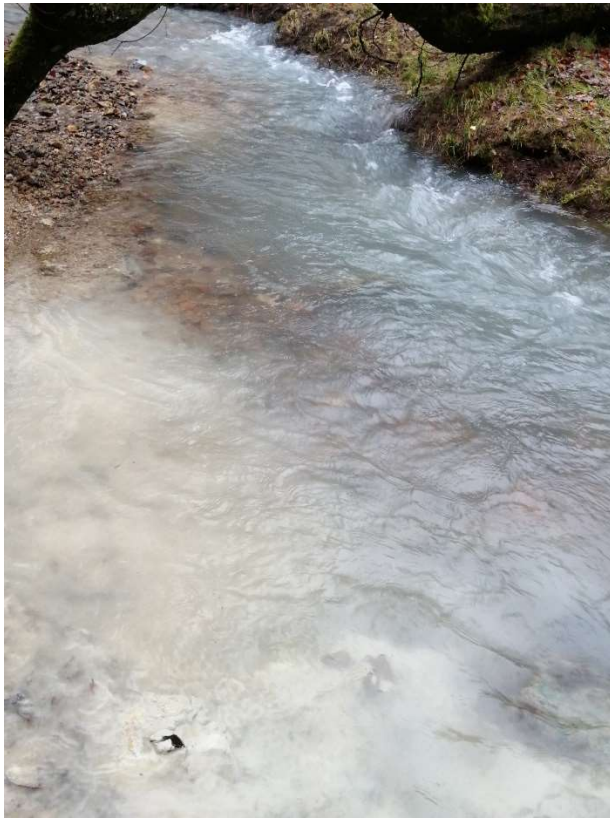
- Seventeen days on following the pollution event of Monday 05 December, thick deposits of kaolin-like material remain on the banks and beds of River Piall (Figures 29 and 30), which is still running chalky white (Figure 31).

Figure 29: Deposits remaining 17 days later below the weir on tributary from Headon China clay works to Quick Bridge on the River Piall recorded by Julia Bertram 1000h 22Dec22

Worse, as long as 35 days after pollution on Monday 05 December, our river banks and bed remain covered with what appears to be a deep layer of kaolin for many miles downstream, depriving all plant and animal life of both light and oxygen (Figures 29, 30, 31, 32 and 33). Whilst there has been significant effort sent clearing sediment from its source overland (Figure 26 and elsewhere), we are not aware of any such effort towards clearing the same sediment from our rivers.

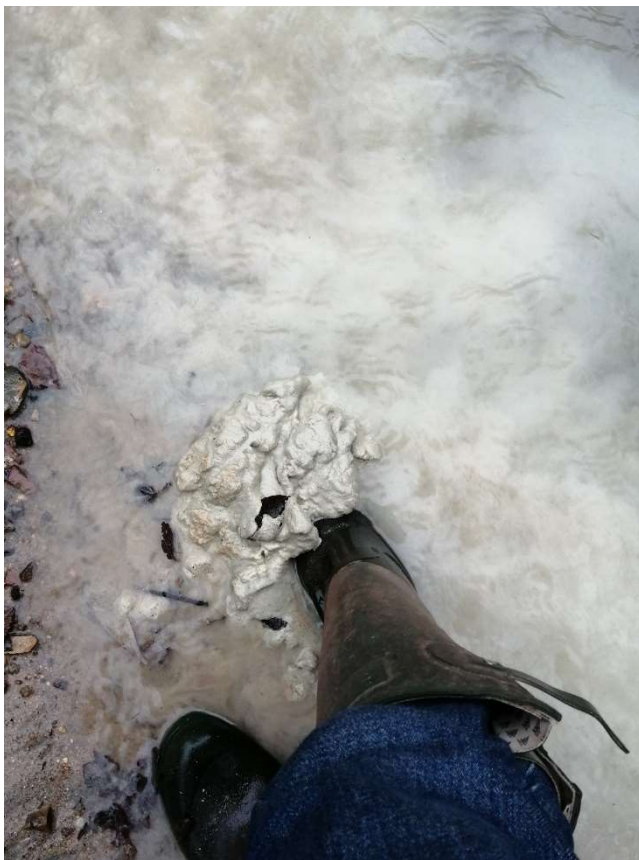
Figure 30: Deposits remaining 17 days later below the weir on tributary from Headon China clay works to Quick Bridge on the River Piall recorded by Julia Bertram 1005h 22Dec22

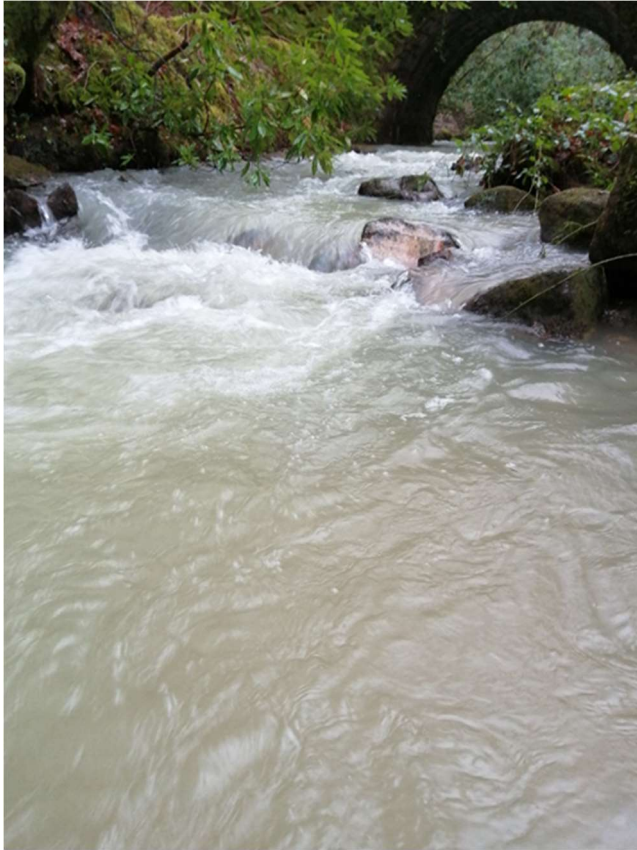
Figure 31: River Piall at Quick Bridge recorded by Julia Bertram 0955 22Dec22

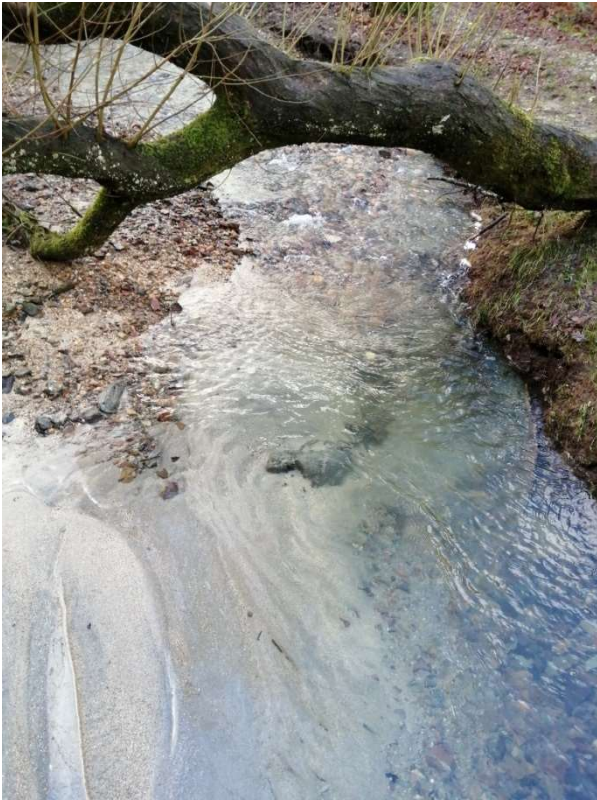
- Thirty five days on following the pollution event of Monday 05 December, deposits of kaolin-like material remain on the banks and beds of River Piall (Figure 32 and 33), which is still running chalky white (Figure 34).

Figure 33: Deposits remaining 35 days later below the weir on tributary from Headon China clay works to Quick Bridge on the River Piall recorded by Julia Bertram 09Jan23

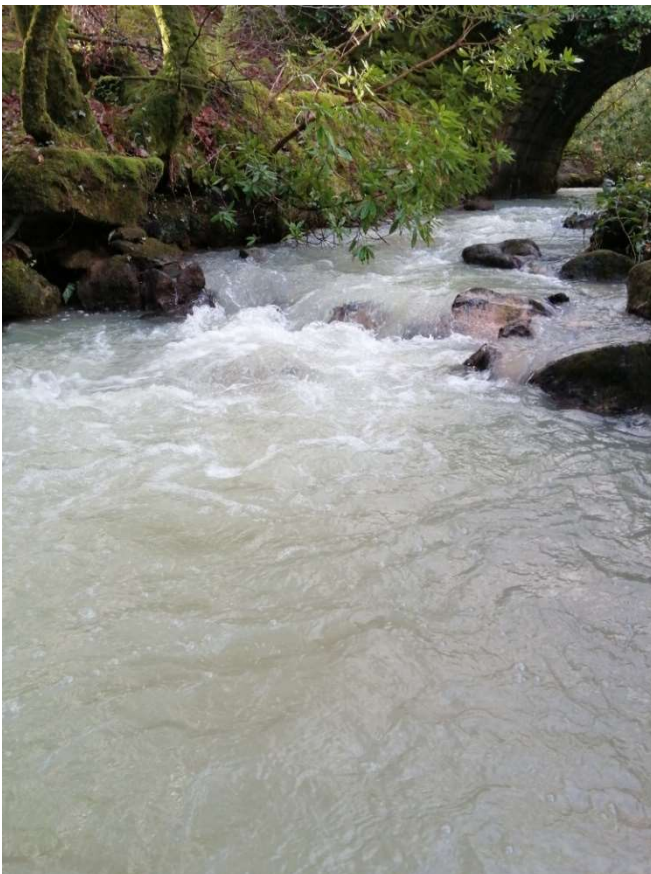
Figure 34: River Piall at Quick Bridge recorded by Julia Bertram 09Jan23
