# Summary of pollution events on Rivers Piall and Yealm: week beginning Monday 05 December 2022

Tony Hawkins and Julia Bertram  
30 January 2023

## 1/4 The River Yealm

## 2/4 Timeline of pollution event

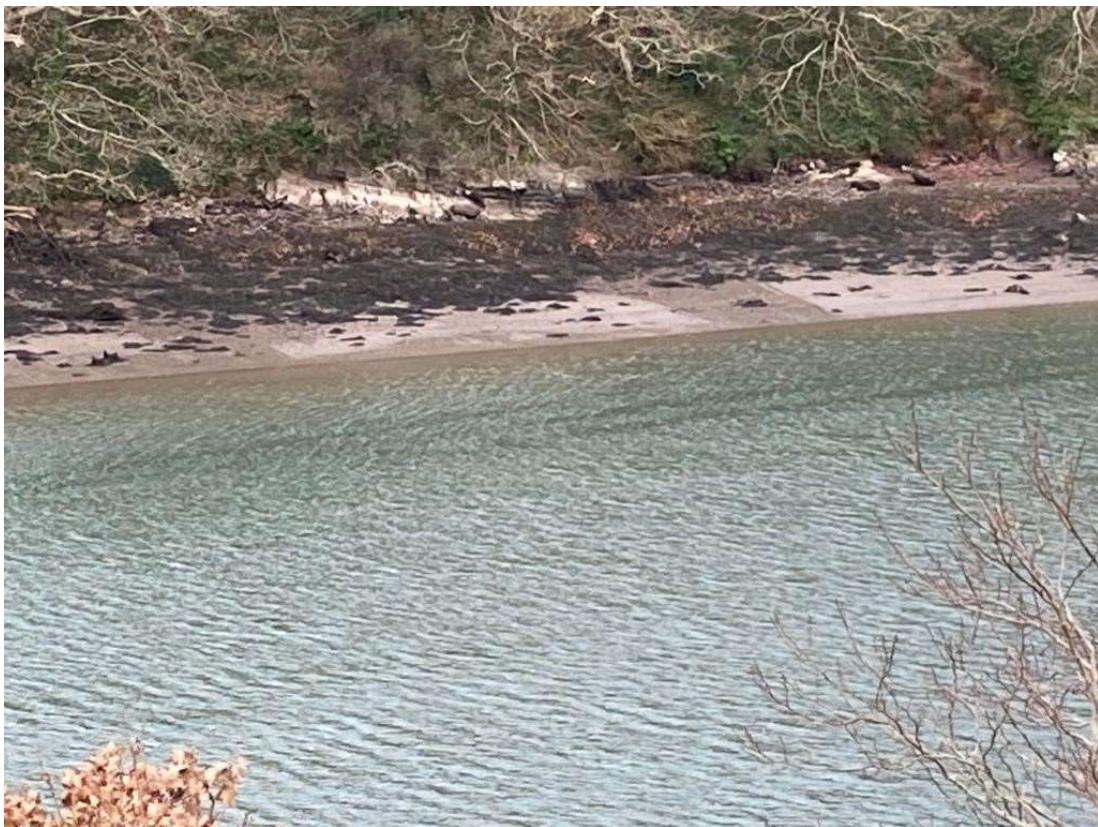
Figure 36: Pale deposits on foreshore of River Yealm at Newton Ferrers recorded by Nicky Tewson 1046h 06Dec22

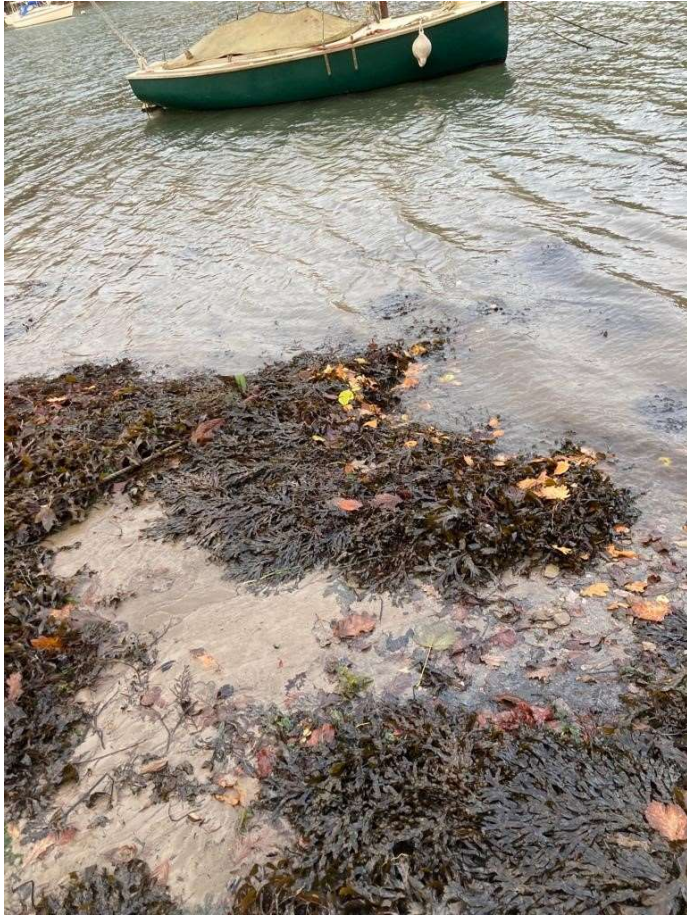
Figure 37: Pale deposits on foreshore of River Yealm at Newton Ferrers recorded by Nicky Tewson 1048h 06Dec22
